Somerset Vernacular Building Research Group
Affiliated to the Somerset Archaeological and Natural History Society
and to The Vernacular Architecture Group

HOUSES Nos. 14 TO 17
High Street, Milborne Port

May 2018

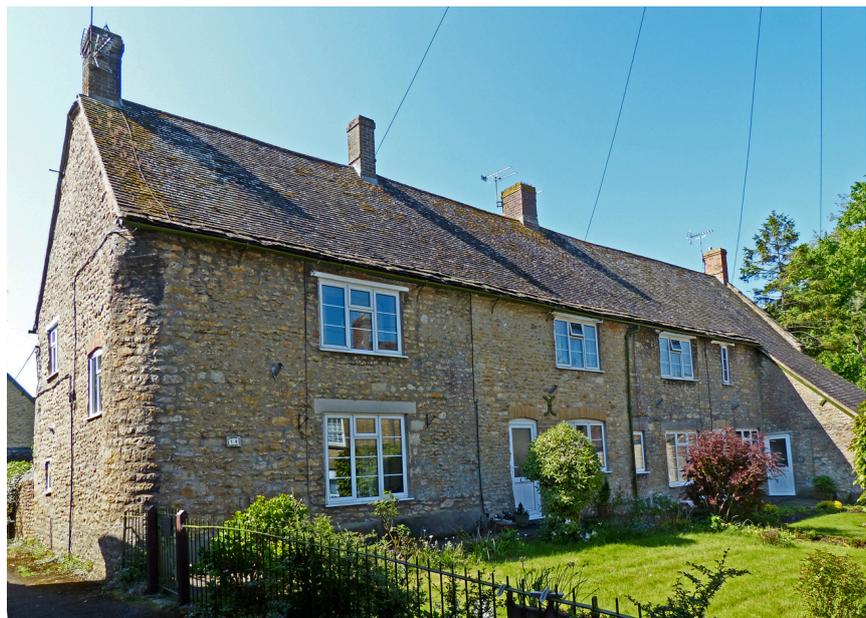
FIG.1. THE HOUSES VIEWED FROM THE NE.

The house is two-storey under a pitched roof and comprises four dwellings. It is built of local rubble stone and the north east corner of the building has been rounded. Windows and doors are all modern upvc replacements. The north (front) of the building has concrete lintels over the ground floor windows of Nos. 14 (at the east end), 16 and 17. Number 15 has segmental heads over the door and window. The upper floor windows are under timber lintels, though there is a segmental headed window in the west gable. Number 17 has a lean-to extension on the north side. At the rear Numbers 15 and 16 have two-storey extensions; No.16 is all brick whilst No.15 has ground floor walls of stone. Number 14 has single storey glazed conservatory. The roof is mainly of plain clay tiles but there are eaves courses of stone tiles, two on the front and four at the rear. The west gable is raised and has stepped copings. There is a brick chimney stack at each gable and two further brick stacks set along the ridge.

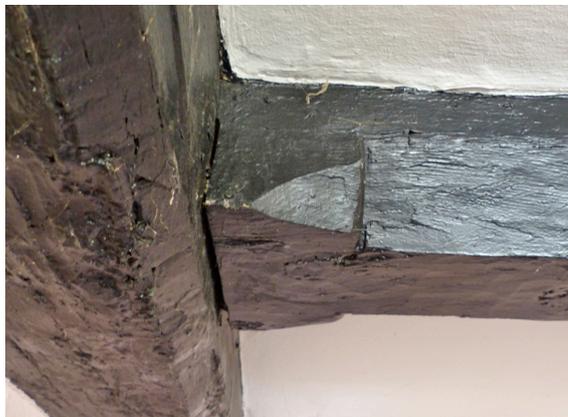
FIG. 6. CHAMFER AND STOP ON BEAM B2

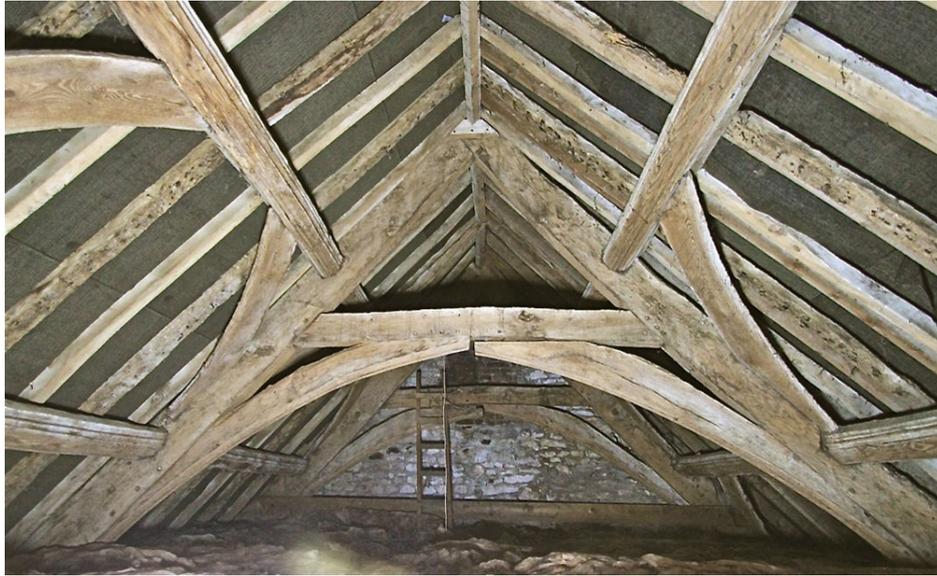
Roof Structure The roof is constructed of oak arch-braced collar trusses and has undergone several phases of repair (Figs. 4 & 8). The 290x120mm principals meet with a plain tenon joint at the apex which was pierced to accept a threaded 100x100mm ridge piece. A roof pitch of 50.3° was measured. The collars, 190x90mm, are slightly cambered and are supported by moulded, open arch braces that meet at the centre of the span; the collars were trestle sawn. Truss numbers are marked on the east faces of the collars and braces (Fig. 11). There are two tiers of moulded purlins, the upper tier being slightly smaller (180mm) in width than the lower tier (210x120mm). The purlins are aligned and the sockets in the principals are cut to accept the purlin profile (Fig. 7). The original common rafters were pegged into the purlins but almost all have been replaced. Between the purlins are two tiers of windbracing. These braces on truss I through to truss III have plain curves that rise towards the centre of the purlin span (Fig. 9). Beyond truss III the braces have a decorative cusped form although most appear to be of a natural form taken, in pairs, from a crooked branch and still retaining a wany edge (Fig. 10). The illustration (Fig.3) shows wind brace positions and styles as they might have appeared. Further cusped windbraces probably continued eastward along the roof.

FIG. 8. GENERAL VIEW WEST OF THE ROOF STRUCTURE, TRUSS II IN FOREGROUND

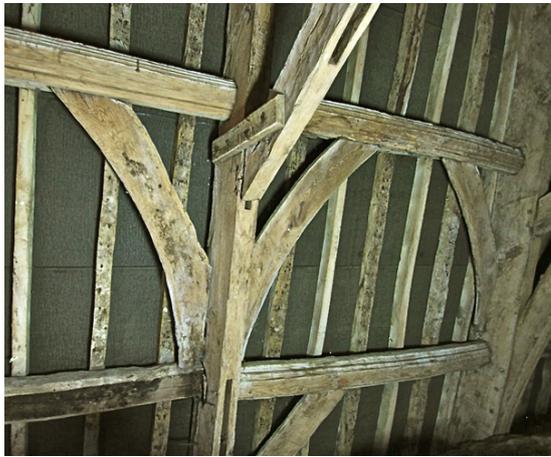
FIG. 9. TRUSS III SOUTH, CURVED WINDBRACES

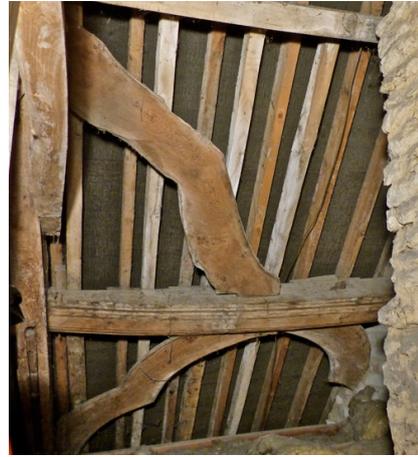
Number 16 has a substantial fire-stack against No.15 and a small hearth on the upper floor. It is possible this was inserted about the same time as that in No.14, representing a time when, perhaps, the building was divided into just two units. In the roof, truss 5 marks a change of wind bracing as the lower tier between trusses 5 and 6 takes a cusped form. The more irregular versions of this form using crooked branches may simply be economic repairs. As truss III coincides with the end of the framed ceiling (mainly in No.17) there is a possibility that there was a timber partition through the building at that position. A partition sill beam replaces an original principal at truss 5.

FIG. 10. CUSPED BRACES AT TRUSS 5 NORTH

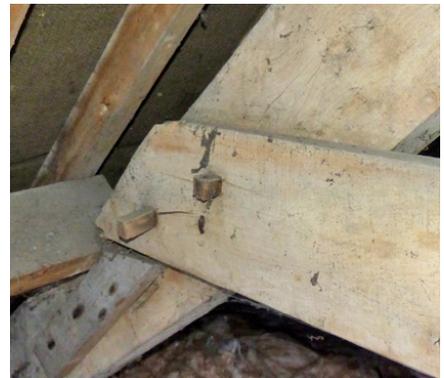
Over No.14 the roof is supported by a single elm truss with a plain tenoned apex. The principals are 280x100mm and are joined by a straight 250x60mm collar, pegged and forelock-bolted to the face (Fig. 12). Two pairs of long crossing struts resting on the two axial ceiling beams support the purlins close to the truss and midway between the truss and the party wall with No.15.

In No.14 the framed ceiling on both floors with step and runout stops suggests perhaps a mid 17th century alteration. The bulky fireplace and stack at F1 were inserted possibly in the early 18th century but unlike at No.16, there is no hearth on the upper floor. The roof truss has been constructed with re-used timber and the method of fixing the collar suggests late 18th century work.

FIG. 12. COLLAR PEGGED AND BOLTED AT TRUSS 9

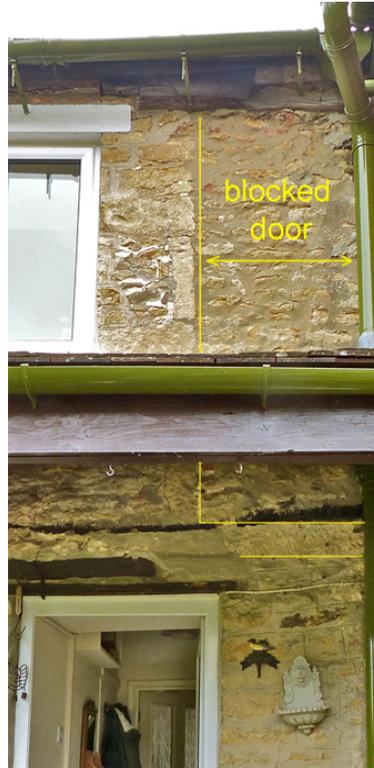
Above the current south door of No.17 are the jamb stones of a blocked first-floor doorway, (Fig. 13), at the foot of which is a roughly dressed large stone that was probably the doorstep. Just to the west of the stone is a timber lintel of an earlier door or window. A bricked-up door, just to the east, is evidence of a doorway that led into the building; a stone step remains in the cupboard beneath the stair of No.16.

FIG. 13. BLOCKED FIRST FLOOR ENTRANCE
AND SILL STONE

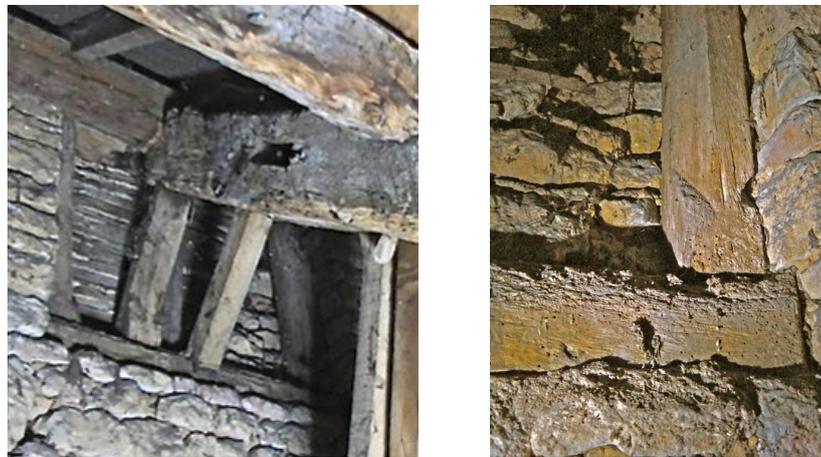
In the lean-to of No.17 there is visible in the main wall an original wooden window frame (Fig.14) situated just below eaves level and blocked with lath and plaster and masonry. The window opening is 90cm wide and the uprights of the oak frame are chamfered and have diagonal stops.

FIG. 14. BLOCKED TIMBER-FRAMED WINDOW AND DETAIL OF DIAGONAL CHAMFER STOP

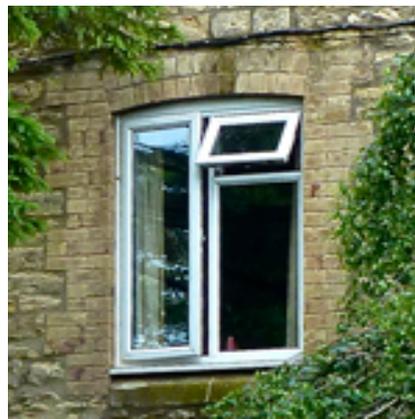
Doors and windows Doors and windows in the dwellings are of modern design and materials fitted into former or more recently created openings, identifiable by whether they have timber or concrete lintels. The exception is a brick-faced opening with a brick segmental head in the west gable wall at first floor level (Fig. 15). Timber lintels in the walls indicate earlier openings.

FIG. 15. WINDOW IN WEST GABLE
