The river and leat from Swatchford to Kingsbury waterfall (Milborne Port)

## River course upstream of Kingsbury waterfall

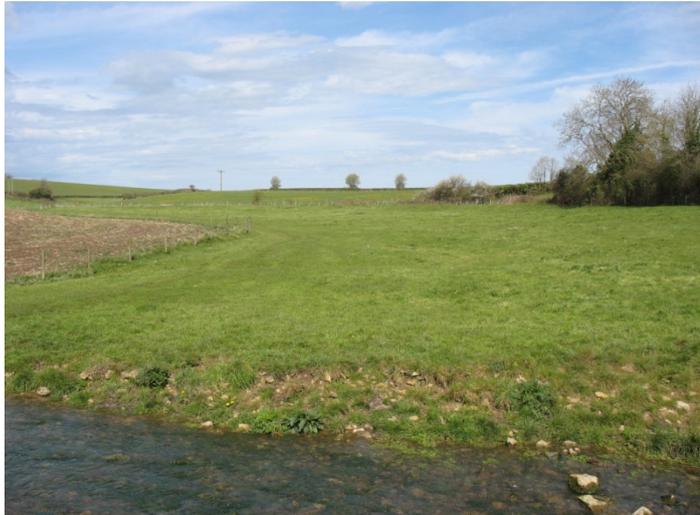
*Image 1*

Looking north from waterfall with river  
river course sweeping to the left.

However, by observation of the fields between Swatchford and Kingsbury waterfall, it is possible to map the flow of the original river course pre-leat by observing the way in which areas of the field (see images 1 + 2 below) and lower lying grass occasionally fill with water during heavy rain/flooding. This field also best shows the result of the difference in height of the leat from what was the original river at its lower level.

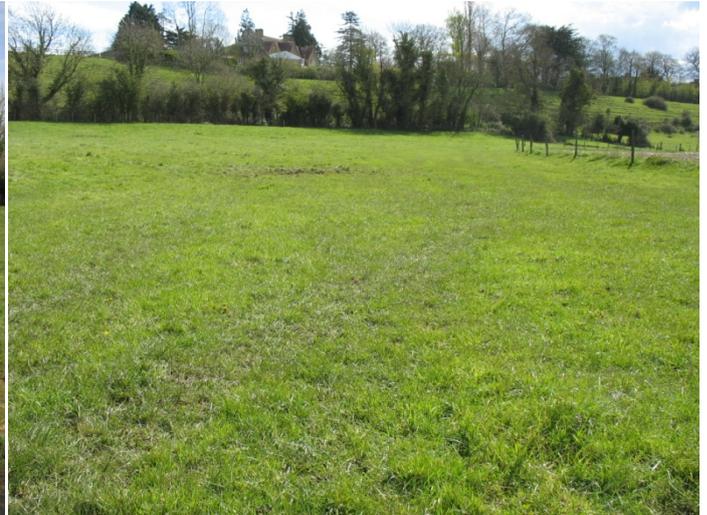
*Image 2*

Looking south towards waterfall original  
original river course to the right.

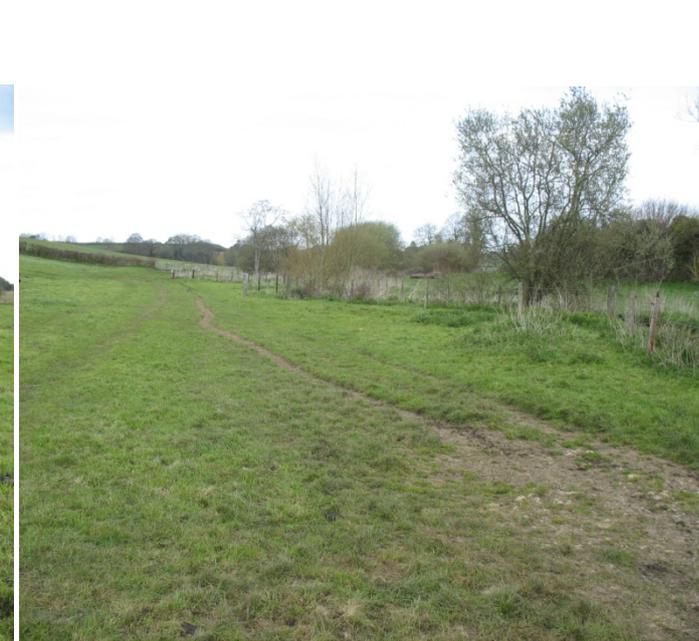
Image 8  
Below Swatchford bridge looking north

This identification of the location of the start of the leat is based on an assumption that in redirecting the river for the leat, it would seem improbable to then plan in bends in the leat; this is best shown on maps 1781 and 1888-1913 above and in image 8 below.
